Brazos River Basin Highlights Report 2021

BRAZOS RIVER BASIN HIGHLIGHTS REPORT 2021

This report is a programmatic update that contains information and updates on on-going activities and projects that address water quality concerns in the lakes and streams of the Brazos River basin. The report also includes a summary of water quality monitoring results, an overview of scheduled routine monitoring for FY 2021, and summarization of the 2020 Integrated Report (IR).

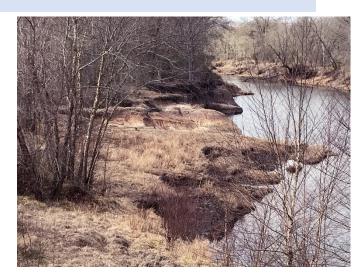
After 10 hours, about 500 newly planted saplings lined the banks.

A riparian zone is the area of land between the water of a stream or river and the higher ground. Sometimes call a rivers banks, this area holds specific benefits for both the quality of the river's water and the habitat for the fish and other water-based creatures living there. The crew split up into two groups of three and went to opposite sides of the stream, where they would begin planting the small tree saplings. Starting upstream near the dam and moving downstream along the banks and up into the floodplain, the crews began slicing into the earth and planting each individual tree for its hopeful journey into adulthood.
