# **Brazos River Basin Highlights Report 2019**

<b>INTRODUCTION</b> .....	<b>1</b>
<b>THIS YEARS HIGHLIGHTS</b> .....	<b>1</b>
Limestone Riparian Restoration Project .....	1
Brazos Basin Instream Flow Monitoring Program to Inform on Environmental Flow Standards..	6
Big Elm Creek Watershed Protection Plan .....	11
Watershed Protection Plan for the Leon River .....	11
Watershed Protection Plan for the Lampasas River .....	12
Watershed Protection Plan for Nolan Creek/South Nolan Creek .....	12
Watershed Protection Plan for the Navasota River Below Lake Limestone .....	14
<b>WATER QUALITY MONITORING</b> .....	<b>14</b>
Descriptions of Water Quality Parameters and Terminology .....	16
Monitoring in the Brazos River Basin .....	20
Brazos Basins Major Watersheds Map .....	21
Watershed of the Salt Fork and Double Mountain Fork of the Brazos River .....	25
Brazos River above Possum Kingdom Reservoir (Segment 1208) .....	26
Miller’s Creek Reservoir (Segment 1208A) .....	26

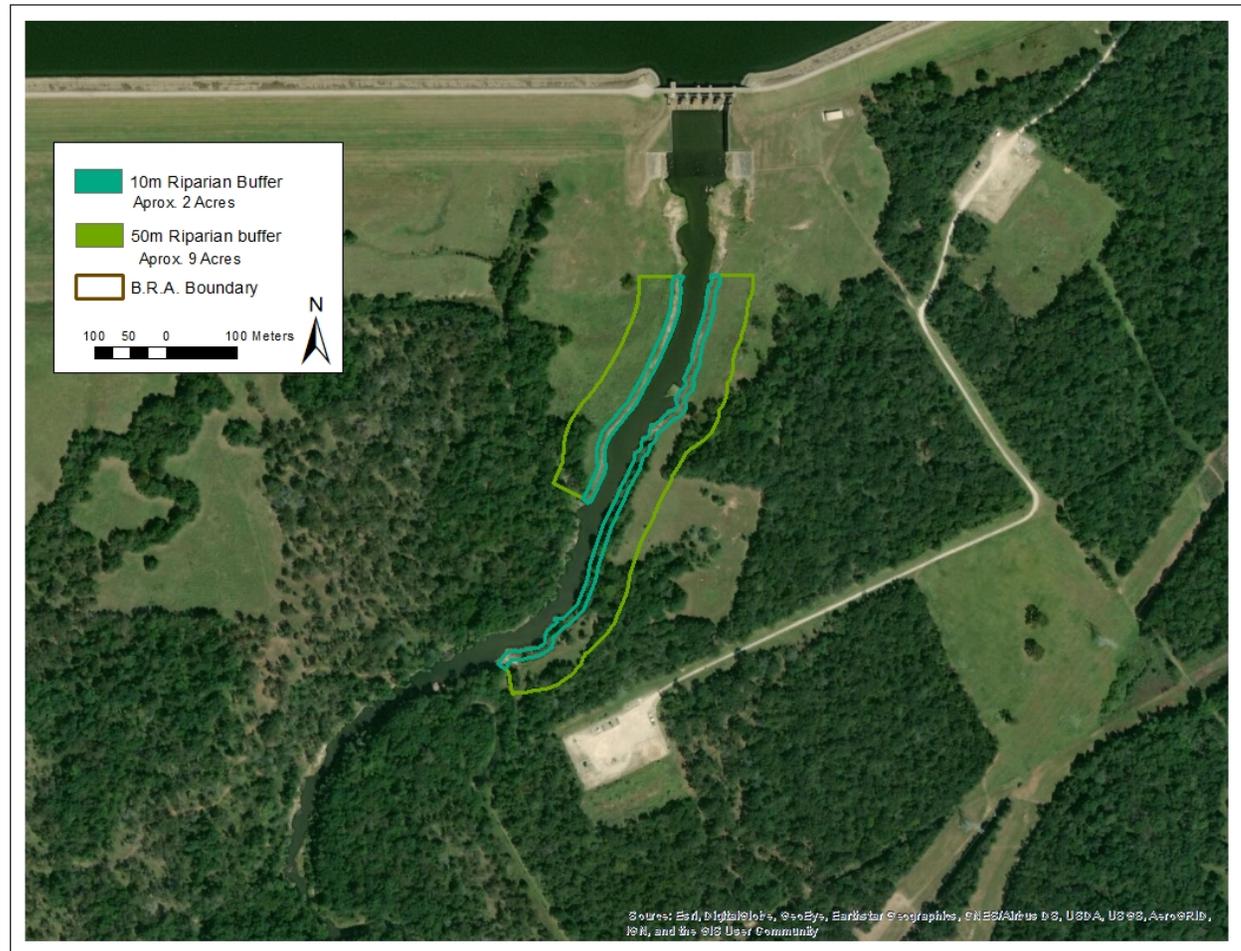
Figure I-1. 10m and 50m Riparian Buffer below Lake Limestone

“Armoring” banks with native grasses, shrubs and trees is a cost effective way to protect against more resource intensive structural repairs. Riparian buffers prevent erosion by reducing water velocities and capturing sediment.

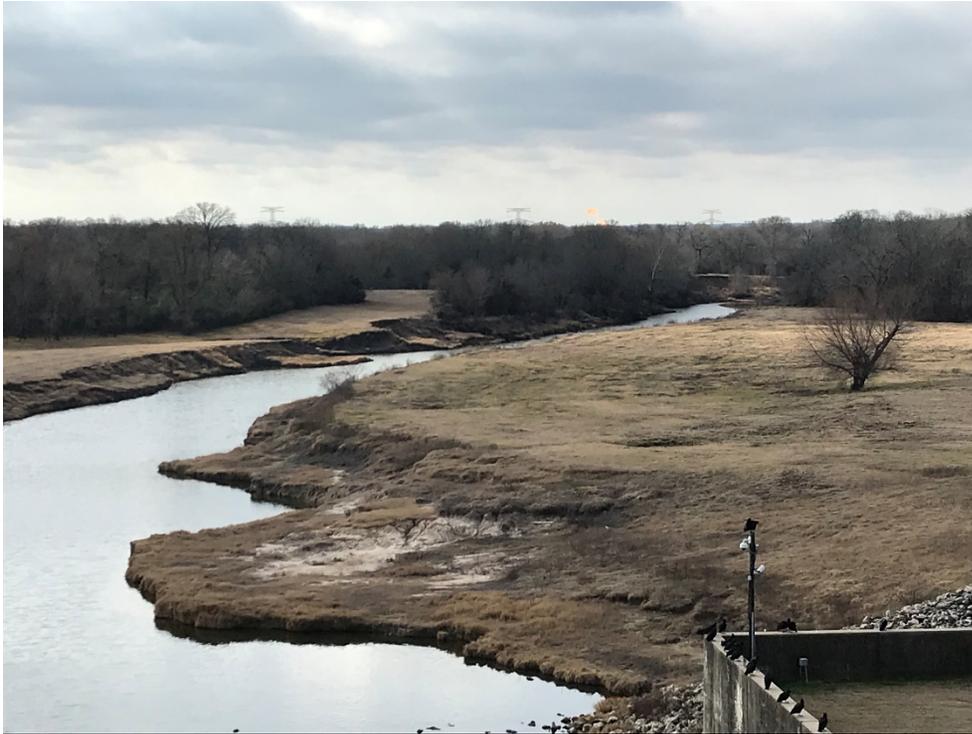
Figure I-2. "Mass Failure" erosion on the Navasota River below Lake Limestone

Blackland and Post Oak soils that are cleared or do not have good stabilizing vegetation are susceptible to mass failures caused by cycles of wetting and drying. (Figure I-2). These mass failures decrease water quality by increasing suspended solids and attached nutrients; increased nutrients introduced in to streams may cause increased algal blooms and associated impacts on water quality. Suspended solids carried downstream may be deposited downstream effectively burying benthic habitats used by fresh water mussels and other aquatic species. Prolonged and intense release of water from the dam could erode structures put in place to prevent erosion.

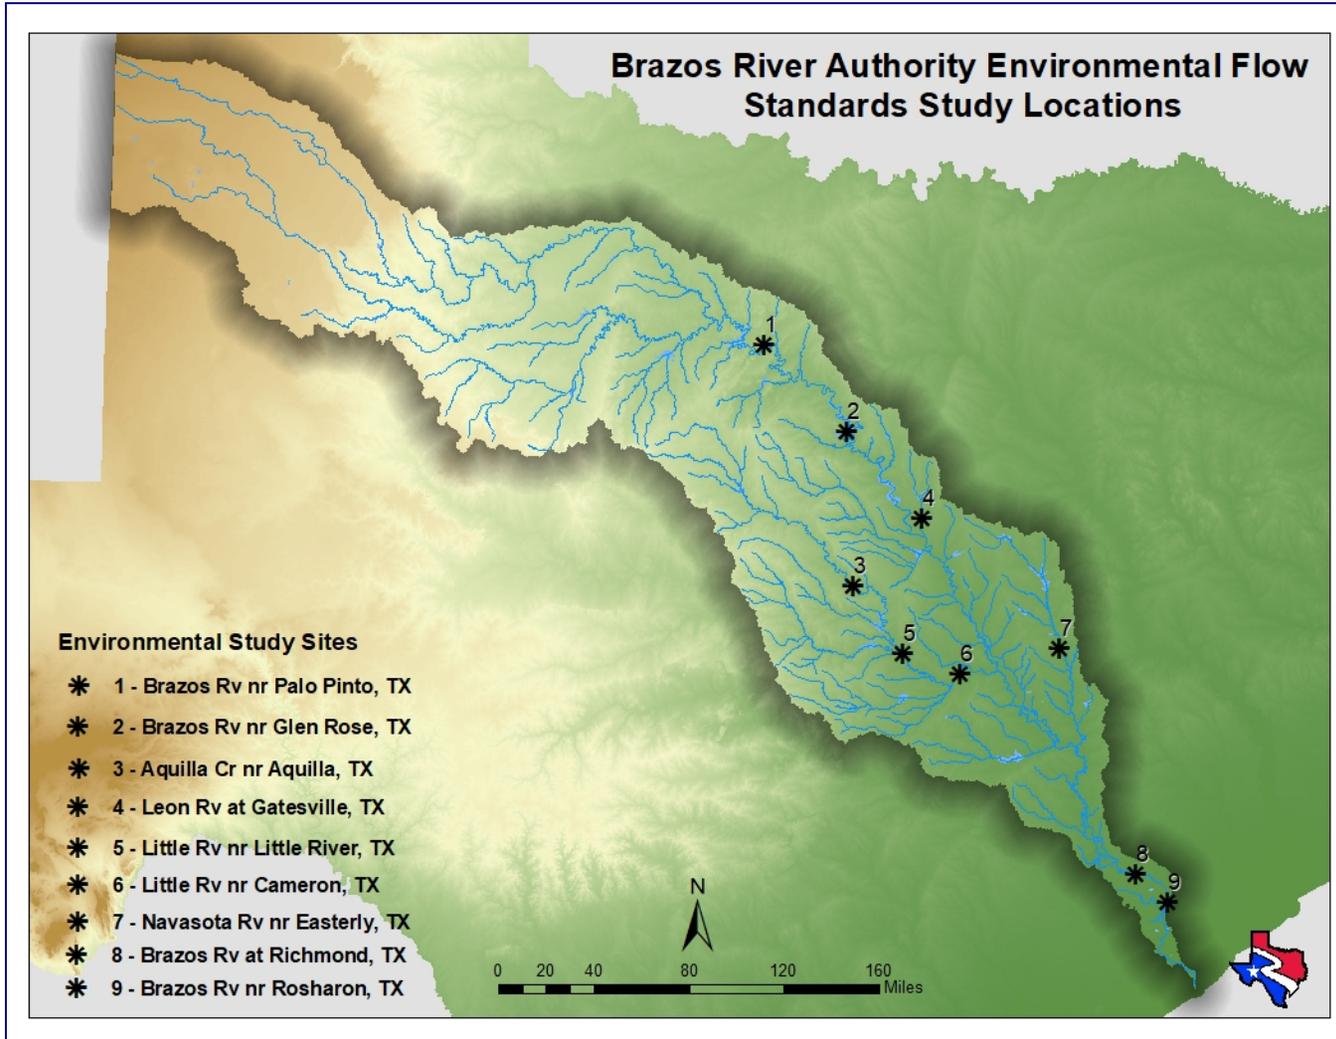
Figure I-3. Brazos River Authority Environmental Study Sites

Components of the studies performed at each site include:

- Discharge, velocity and depth point measurements
- Temperature, pH, Conductivity, and Dissolved Oxygen Concentration
- Fixed photography, instream cover, habitat types, and channel surveys
- Macroinvertebrates, mussels (if present), and fish assemblage
- Riparian tree surveys
- Channel cross-section surveys
- Sediment sampling at the cross-sections

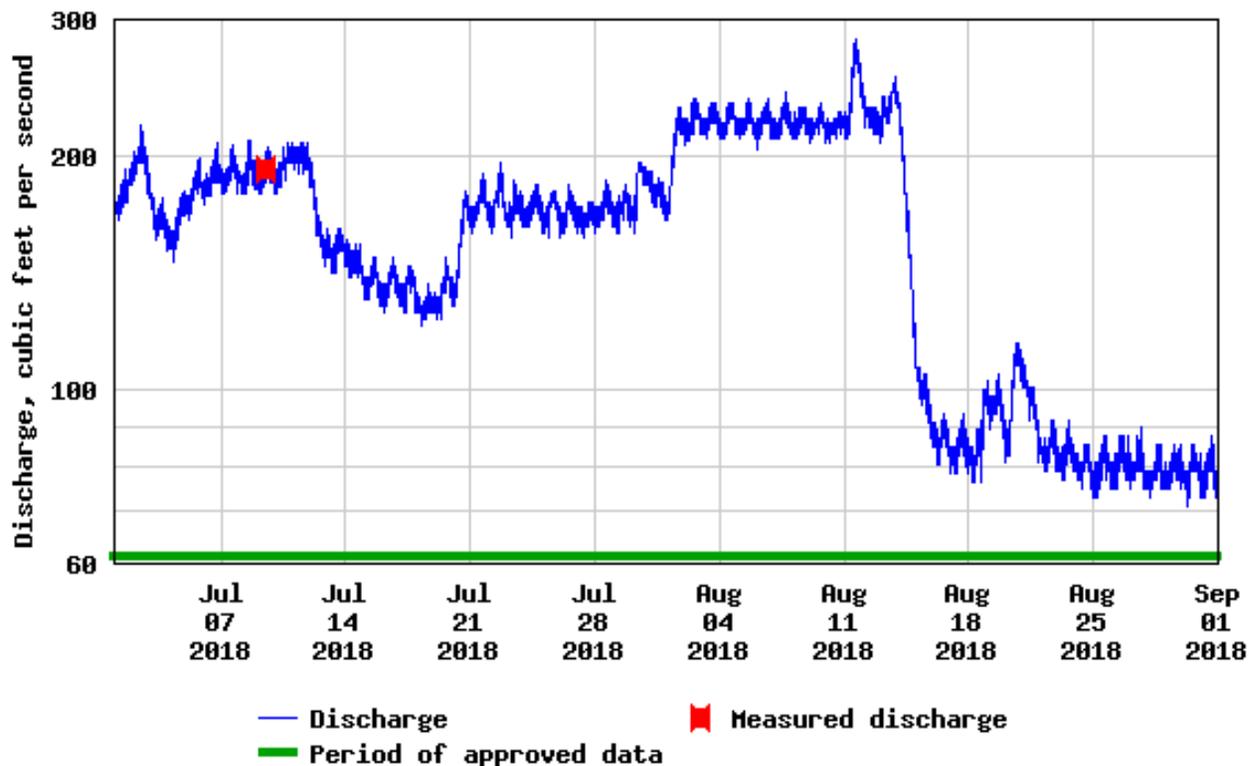
Figure I-4. USGS Discharge at Palo Pinto gauge July through August 2018.

204 cfs to a range of 61-75 cfs approximately two weeks before the assessments were conducted (Figure I-4). Speculatively, this result could involve the influence of rapid change in instream habitat dynamics related to depth and velocities.
